USACERL Special Report 95/05  
June 1995

# John Martin's Home?: Historical and Archaeological Investigations of Site 9Mu56, Murray County, Georgia

1. AGENCY USE ONLY (Leave Blank)		2. REPORT DATE July 1995	3. REPORT TYPE AND DATES COVERED Final	
4. TITLE AND SUBTITLE John Martin's Home?: Historical and Archaeological Investigations of Site 9Mu56, Murray County, Georgia			5. FUNDING NUMBERS  MIPR FC-92-0045

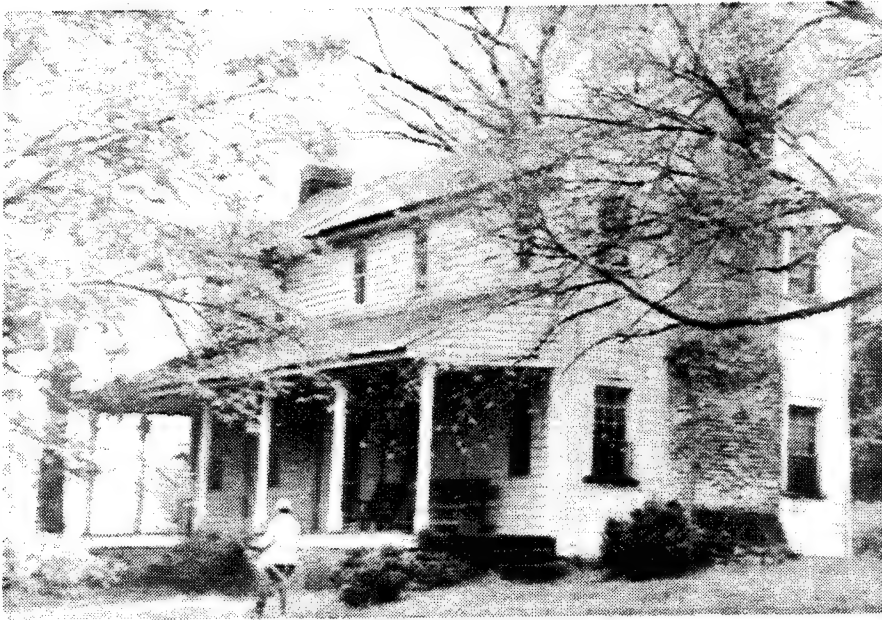
The Martin house was of frame construction with a rock foundation (Figures 2.6, 2.7, 2.8, 2.9). A two-story I-plan, it had two rooms flanking a central hall on each floor with a cantilevered staircase in the center of the house. Brick chimneys at either end of the house provided a fireplace to each room. A federal agent described the house in 1837 as "frame dwelling house 36 x 33, 2 stories high, 3 brick chimneys, 5 fireplaces, 128 light (window panes) windows, good floors, and doors all well finished, worth \$4,000.00" (Davis 1990:61). Curiously, the 1968 appraisal of lot number 401 describes the dwelling house at 9Mu56 as 18 x 46 feet (Pryor 1969). The reason for the size discrepancy is unknown. The discrepancy in the width, 33 feet in 1837 and 18 feet in 1968, can be explained in that the nineteenth century description included porches, while the 1968 appraisal obviously did not. However, why the length of the house was recorded as 36

Figure 2.6 Pre-1969 Photograph of the Front of the Structure at 9Mu56 Looking Southwest (Courtesy of Robert Davis).

Figure 2.7 Photograph of the Structure at 9Mu56 Before Removal Looking Southwest (Courtesy of Joe Blackmon, U.S. Army Corps of Engineers).

Figure 2.8 Pre-1969 Photograph of the Rear of the Structure at 9Mu56 Looking South (Courtesy of Joe Blackmon, U.S. Army Corps of Engineers).

Figure 2.9 Pre-1969 Photograph of the Front of the Structure at 9Mu56 Looking West (Courtesy of Jim Nolan).

feet in 1837 and 46 feet in 1968 is difficult to explain. Perhaps one of the descriptions is a typographical error.
